ASBESTOS CONTAINING BUILDING MATERIALS INSPECTION REPORT

DEPARTAMENTO DE LA FAMILIA

SAMPLING CONDUCTED AT
DEPARTAMENTO DE LA FAMILIA
AVE. BARBOSA #306
SAN JUAN, PR 00917

ZEM-17266

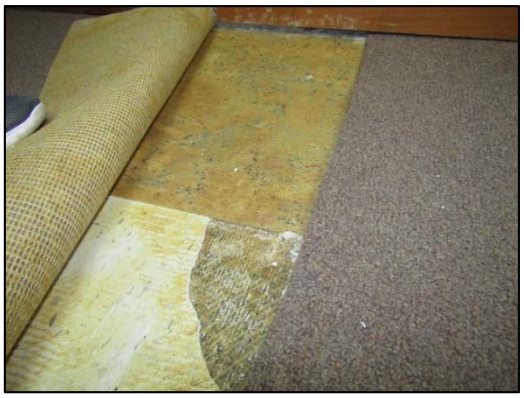
2nd Floor
Asbestos containing vinyl tiles & associate mastic
