LEAD BASED PAINT INSPECTION REPORT

DEPARTAMENTO DE LA FAMILIA

SAMPLING CONDUCTED AT
DEPARTAMENTO DE LA FAMILIA
AVE. BARBOSA #306
SAN JUAN, PR 00917

ZEM-17266

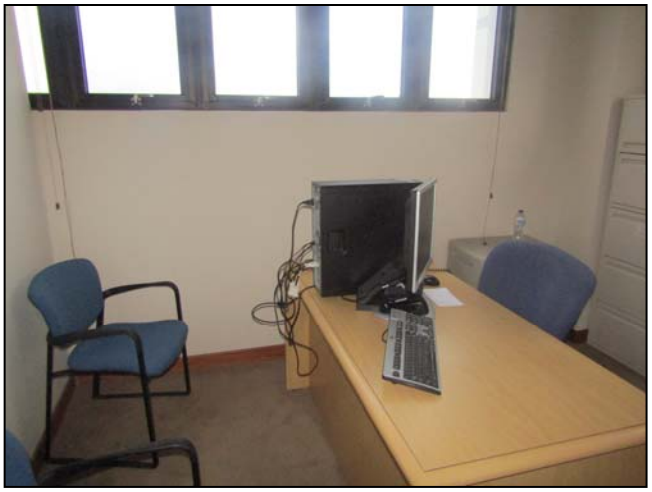
Area 3-49
Lead based paint on Wall B
