Lead-Based Paint Inspection Report

Various Buildings
Located at Fort Allen,
Juana Díaz, Puerto Rico

Client:
PRNG

ZEM-25195
July 2025

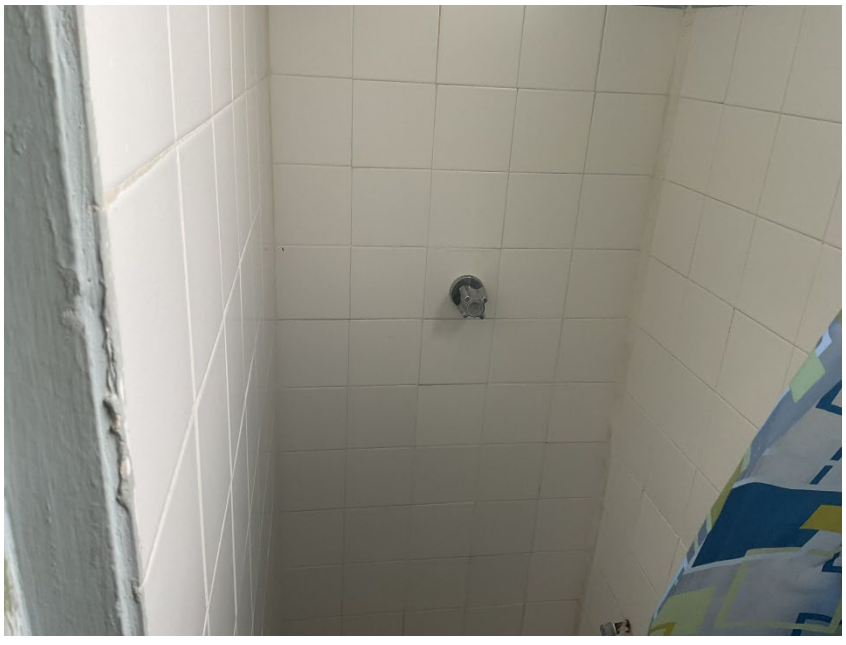
Photo No. 1965	**Date:** 06/25/2025	
Description: **Bldg. #358, Area 1-7** Lead-containing ceramic wall tiles.

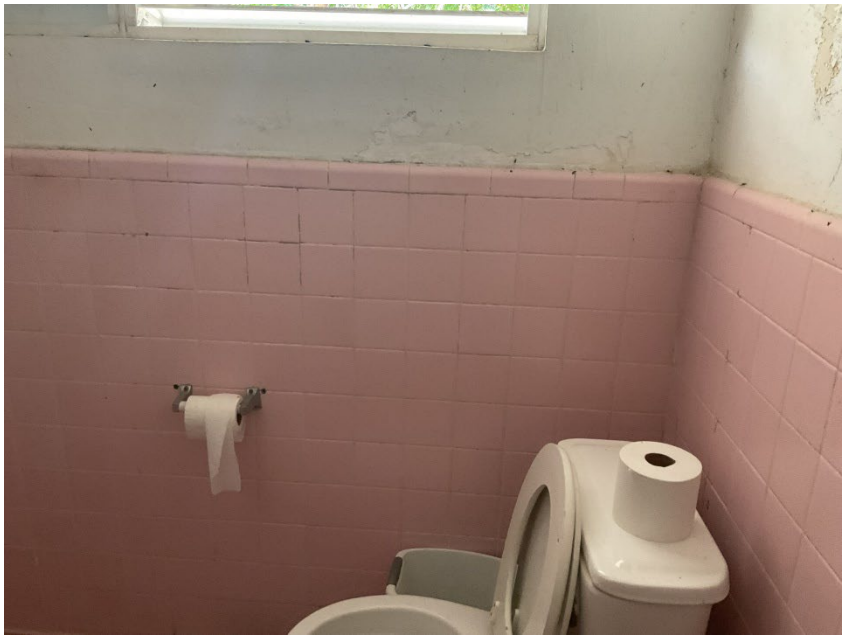
Photo No. 4721	**Date:** 06/25/2025	
Description: **Bldg. #133, Area 2-5** Lead-containing ceramic wall tiles.
