Lead-Based Paint Inspection Report

Various Buildings
Located at Camp Santiago,
Salinas, Puerto Rico

Client:
PRNG

ZEM-25195
July 2025

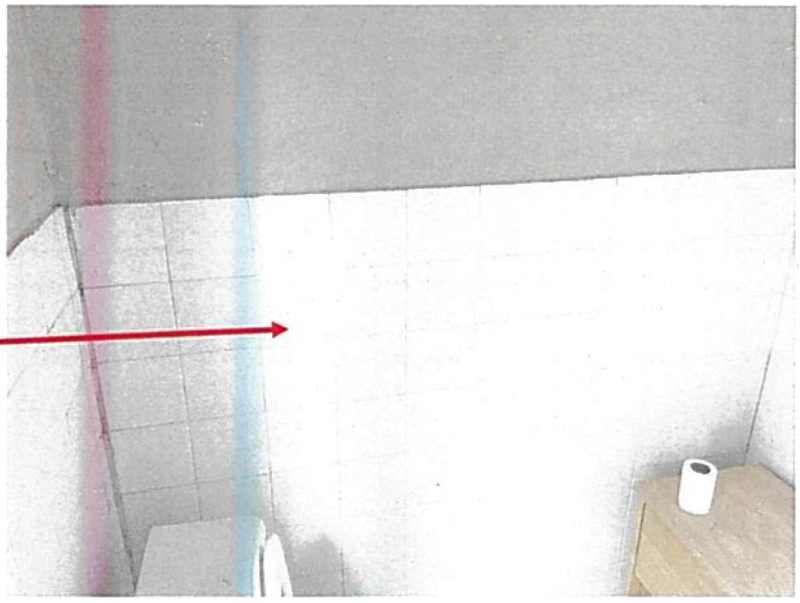
Area	Component	Color	Substrate	Approximate Amount
1-12	Wall Tiles	White	Ceramic	115 Ft^2

Photo No. 1198	Date: 06/25/2025	
Description: **Bldg. #33, Area 1-12** Lead-containing ceramic wall tiles.

According to the DRNA lead regulations, before demolishing a structure containing lead-based paint, the contaminated surfaces or substrates must be abated or removed. The abatement firm must be certified as an abatement firm by the DRNA.

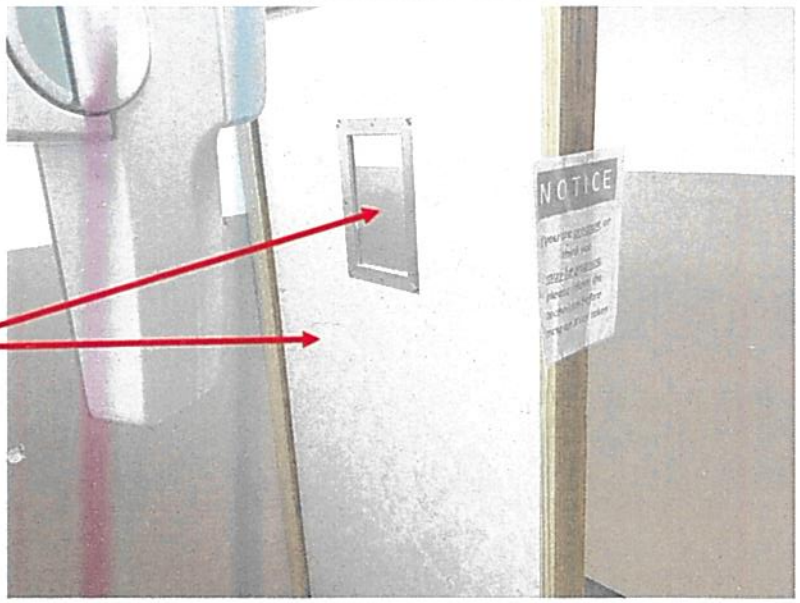
Area	Component	Color	Substrate	Approximate Amount
1-16	Partition	Cream	Wood	1 Unit
	Partition Crystal	Clear	Glass

Photo No. 4739	Date: 06/30/2025	
Description: **Bldg. #589, Area 1-16** Lead-based painted wooden partition & lead-containing leaded glass.
