Asbestos Containing Materials Inspection

SAMPLING CONDUCTED AT:
BUILDING S-1294-0-80-00 & EXT.

Located at Road PR-686 Km. 1.4 Urb. Cabo Caribe in Municipality of Vega Baja, PR

GES Project # -2025-231

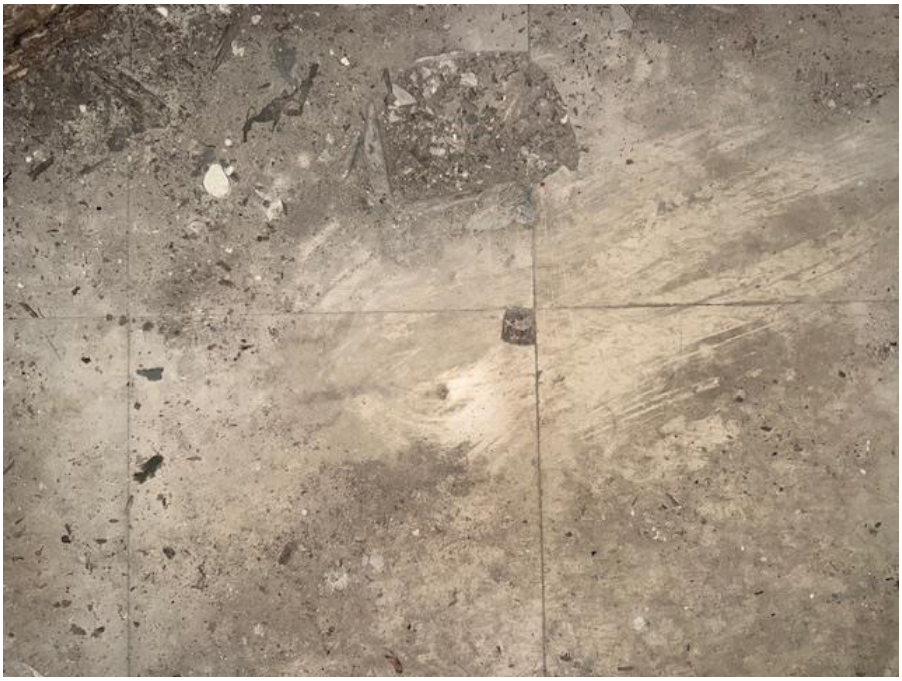
SAMPLE- 2025-231-AR-07

2025-231-AR-07	***Building 1- Room 7- Beige Vinyl Floor Tile 12"x 12"***	*Misc.*	***2% Chrysotile***	***NF***			*X*
2025-231-AR-08	***Building 1- Room 65- Beige Vinyl Floor Tile 12"x 12"***	*Misc.*	***3% Chrysotile***	***NF***			*X*
2025-231-AR-09	***Building 1- Room 22- Beige Carpet (Floor Covering)***	*Misc.*	***NO DETECTED***	***NF***			*X*
2025-231-AR-10	***Building 1- Room 24- Beige Vinyl Floor Tile 12"x 12"***	*Misc.*	***NO DETECTED***	***NF***	***LAYER #1***		*X*
2025-231-AR-11	***Building 1- Room 24- Beige Vinyl Floor Tile 12"x 12"***	*Misc.*	***NO DETECTED***	***NF***	***LAYER #2***		*X*
2025-231-AR-12	***Building 1- Room 24- Beige Vinyl Floor Tile 12"x 12"***	*Misc.*	***NO DETECTED***	***NF***	***LAYER #1***		*X*
2025-231-AR-13	***Building 1- Room 24- Beige Vinyl Floor Tile 12"x 12"***	*Misc.*	***NO DETECTED***	***NF***	***LAYER #2***		*X*

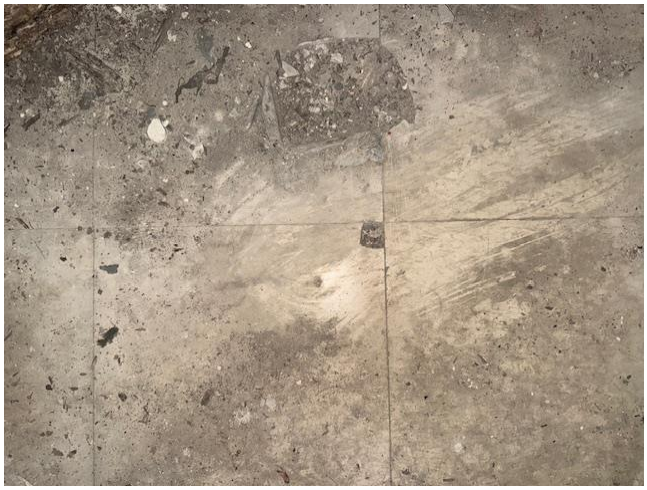
MATERIALS	FUNCTIONAL SPACES	% WITH ASBESTOS	APPROX. QUANTITY
Beige Vinyl Floor Tiles 12"x 12" & Black Mastic	Building S-1294-0-80-00 & Ext. (Building 1)- Various Functional Spaces	2-3% Chrysotile	9,470 sq. ft. approx. (View Appendix's VII & VIII)

Blg. 1- Various Functional Spaces- Beige Vinyl Floor Tiles 12"x 12" & Black Mastic with Asbestos

Global Environmental Services LLC recommends the owner or representative of the owner to hire a Certified Company by Department of Natural and Environmental Resources of Puerto Rico to removal and dispose positive area with Asbestos Containing Material if is going to touch, remodeling or demolish the reference project.

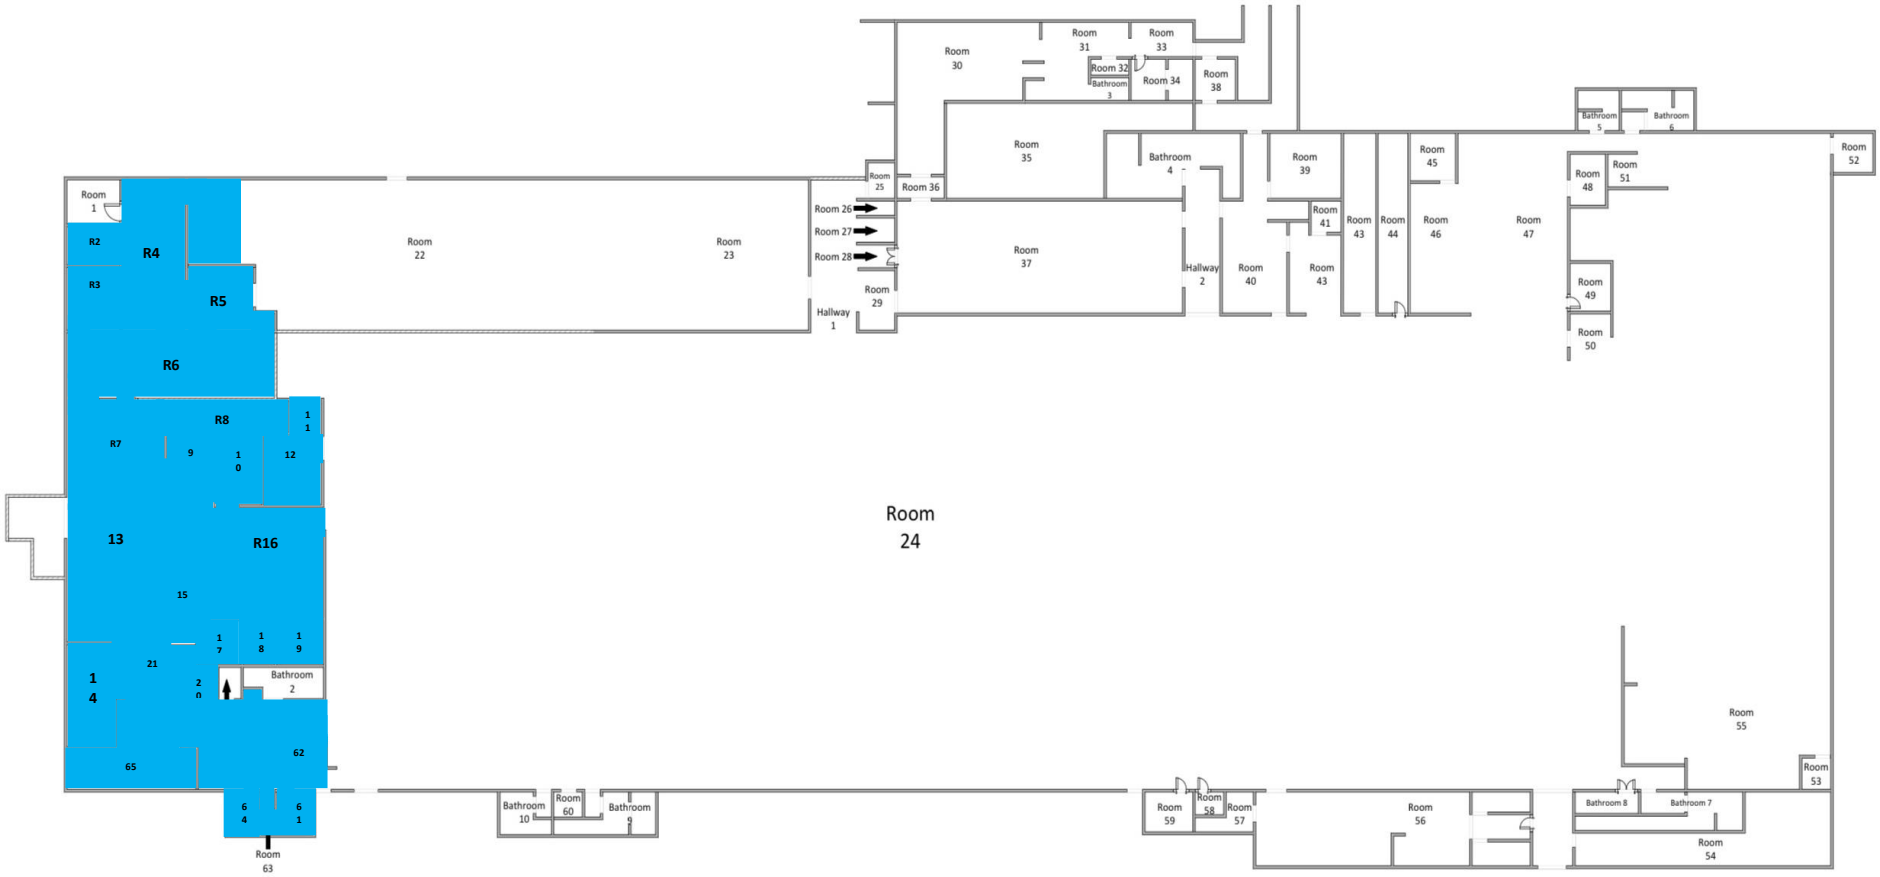
ACM POSITIVE RESULTS LOCATIONS- BUILDING S-1294-0-80-00 & EXT. (BUILDING 1)

= BEIGE VINYL FLOOR TILES 12"X 12" & BLACK MASTIC WITH ASBESTOS
