Lead Based Paint Inspection

SAMPLING CONDUCTED AT:
BUILDINGS S-1535-0-02-00
WATER FRONT INDUSTRIAL PARK

Located at Road PR-64 Algarrobo Ward in Municipality of Mayaguez, PR

GES Project # -2025-261

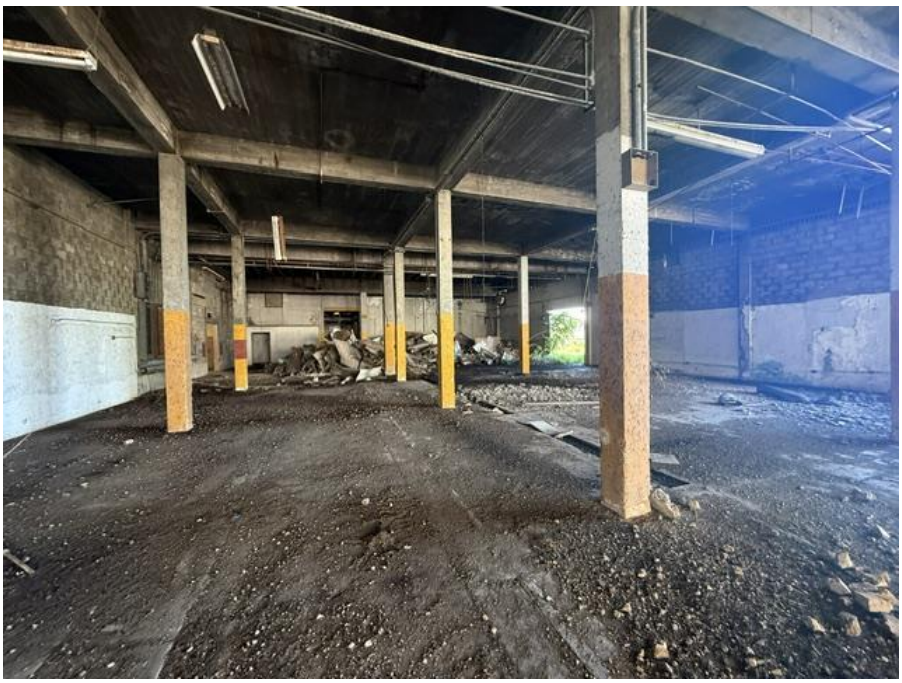
Main Building- Room 3- Ceramic Wall Tiles with Lead Based Paint

Global Environmental Services LLC recommends the owner or representative of owner to hire a Company Certified in the Department of Natural and Environmental Resources (DNER) of Puerto Rico to mitigate and dispose positive areas with Lead Based Paint if is going to touch or demolish the project areas.
