Asbestos Containing Materials Inspection

SAMPLING CONDUCTED AT:
BUILDING T-0792-0-67-00

Located at Road PR-182 Km. 100.5 in Municipality of Yabucoa, PR

GES Project # -2025-263

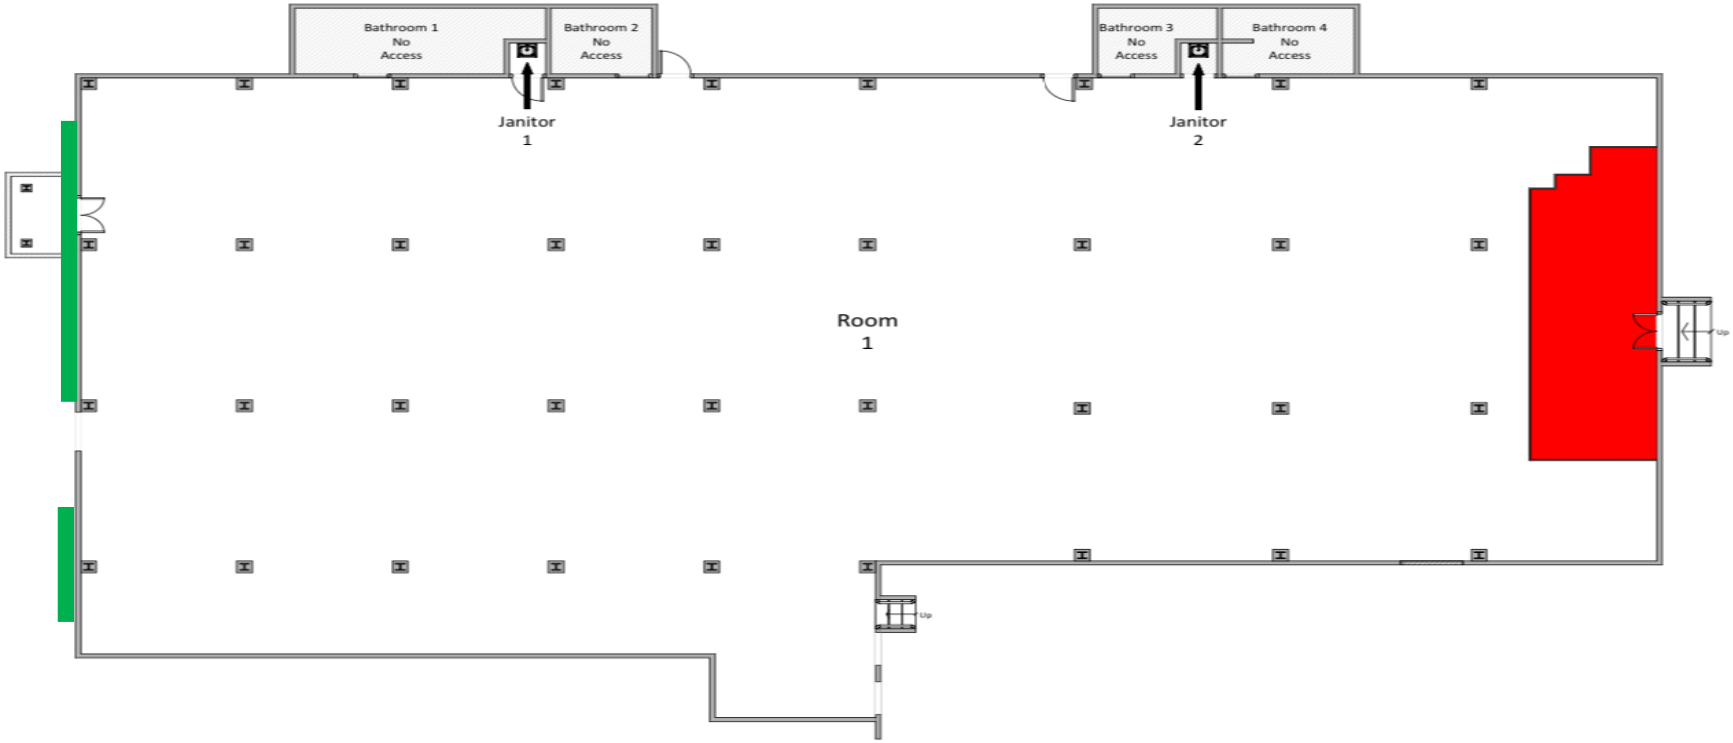
ACM POSITIVE RESULTS LOCATIONS- BUILDING T-0792-0-67-00

TABLE 1.0 – SUMMARY OF MATERIALS WITH ASBESTOS			
FUNCTIONAL SPACES	**MATERIALS**	**% WITH ASBESTOS**	**APPROX. QUANTITY**
Room 1	**Beige & Grey Vinyl Floor Tiles 12" x 12" & Black Mastic**	**2-3% Chrysotile**	**770 sq. ft. approx. (View Appendix's VII & VIII)**
Exterior- Rear Wall	**Grey Upper Wall Panels**	**15% Chrysotile**	**96 sq. ft. approx. (View Appendix's VII & VIII)**
Rooftop	**Roofing Materials**	**3-5% Chrysotile**	**32,650 sq. ft. approx. (View Appendix's VII & VIII)**
Bathrooms 1, 2, 3 & 4	**All Materials**	**ASSUMED**	**To be determined (NO ACCESS)**

= BEIGE & GREY VINYL FLOOR TILES 12"X 12" & BLACK MASTIC (ALL LAYERS) WITH ASBESTOS

= GREY UPPER WALL PANELS WITH ASBESTOS

If remodeling or demolishing activities will be conducted in the nearest future it is recommended to remove all Asbestos Containing Materials present within the project as to comply with NESHAP/DNER requirement.

Global Environmental Services LLC recommends the owner or representative of the owner to hire a Certified Company by Department of Natural and Environmental Resources of Puerto Rico to removal and dispose positive area with Asbestos Containing Material if is going to touch, remodeling or demolish the reference project.

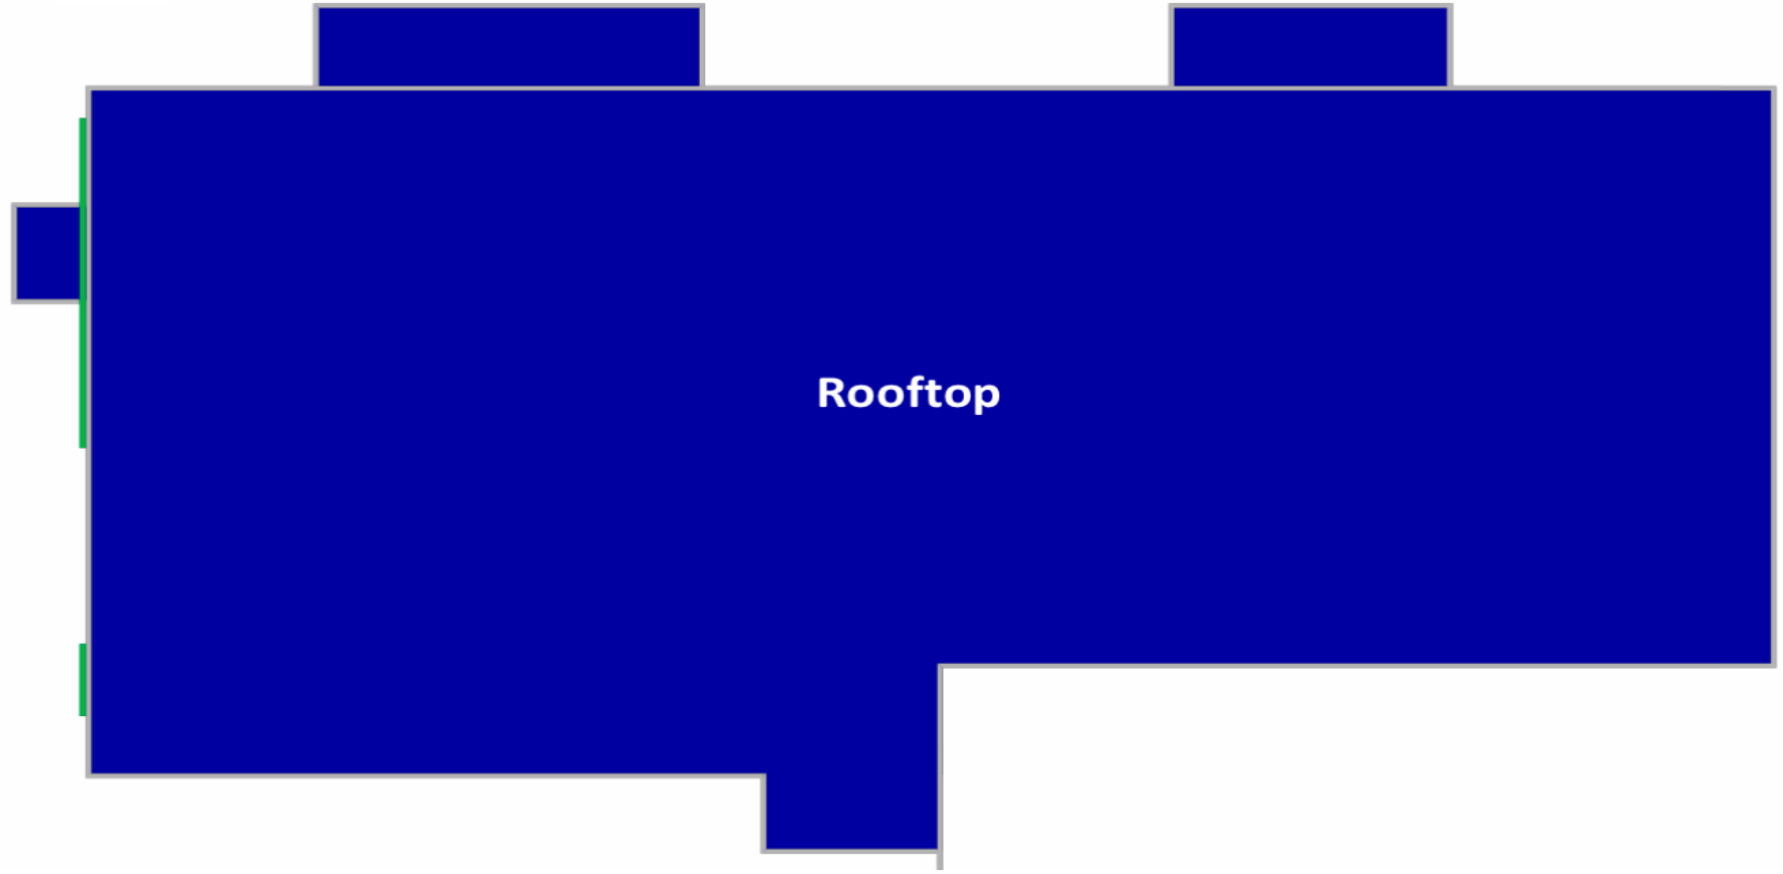
ACM POSITIVE RESULTS LOCATIONS- BUILDING T-0792-0-67-00

NOTE: THE HIRED ENVIRONMENTAL CONTRACTOR HAS TO CLEAN UP THE ROOFING MATERIAL DEBRIS FROM BOTH INSIDE AND OUTSIDE THE BUILDING FLOOR, AS IT CONTAINS ASBESTOS CONTAINING MATERIALS.

= ROOFING MATERIALS WITH ASBESTOS
