Asbestos Containing Materials Inspection

SAMPLING CONDUCTED AT:
BUILDING T-0792-0-67-00

Located at Road PR-182 Km. 100.5 in Municipality of Yabucoa, PR

GES Project # -2025-263

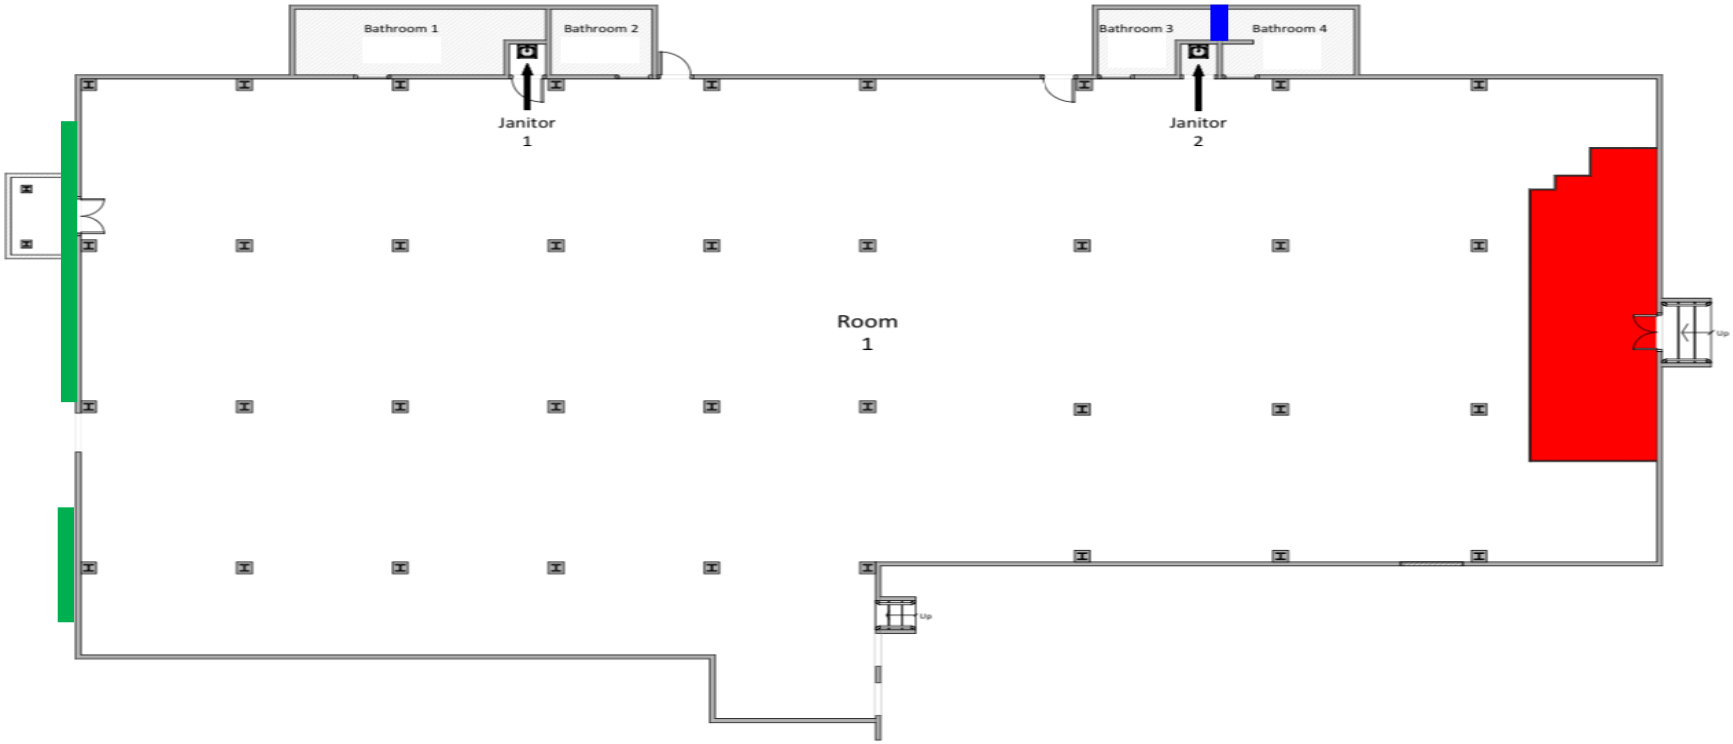
ACM POSITIVE RESULTS LOCATIONS- BUILDING T-0792-0-67-00

= BEIGE & GREY VINYL FLOOR TILES 12"X 12" & BLACK MASTIC (ALL LAYERS) WITH ASBESTOS

= GREY UPPER WALL PANELS WITH ASBESTOS

= GREY WALL PANELS WITH ASBESTOS

Global Environmental Services LLC recommends the owner or representative of the owner to hire a Certified Company by Department of Natural and Environmental Resources of Puerto Rico to removal and dispose positive area with Asbestos Containing Material if is going to touch, remodeling or demolish the reference project.

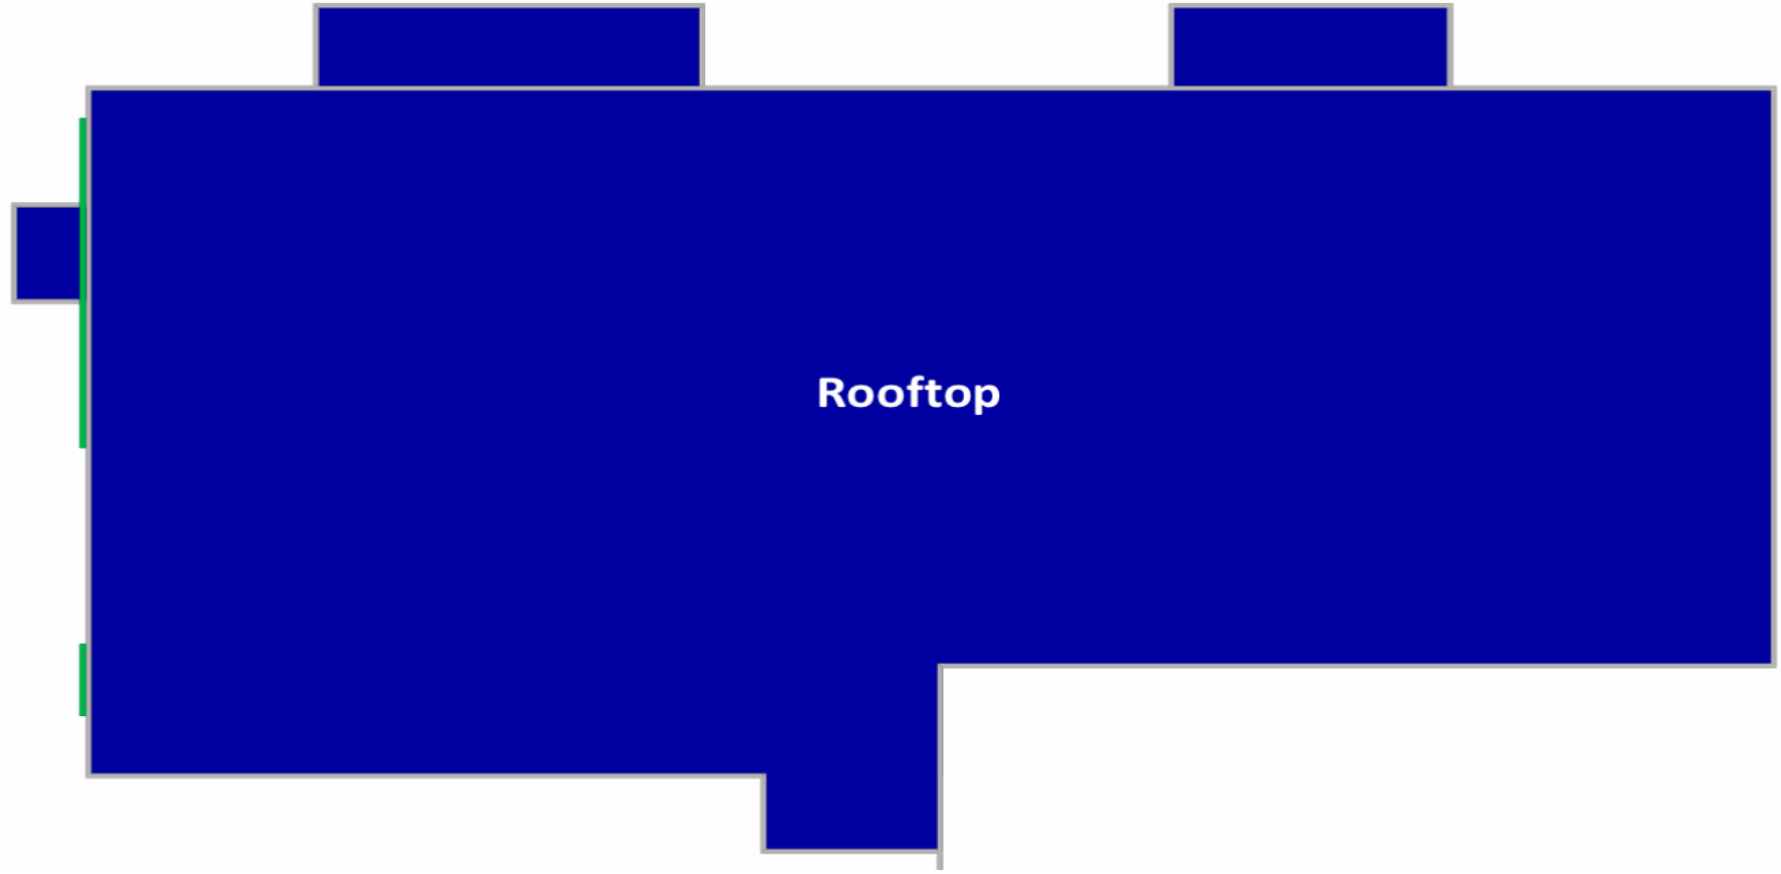
ACM POSITIVE RESULTS LOCATIONS- BUILDING T-0792-0-67-00

= ROOFING MATERIALS WITH ASBESTOS

NOTE: THE HIRED ENVIRONMENTAL CONTRACTOR HAS TO CLEAN UP THE ROOFING MATERIAL DEBRIS FROM BOTH INSIDE AND OUTSIDE THE BUILDING FLOOR, AS IT CONTAINS ASBESTOS CONTAINING MATERIALS.
