Lead Based Paint Inspection

SAMPLING CONDUCTED AT:
BUILDING T-0336-0-56-00
QUEBRADA GRANDE INDUSTRIAL PARK

GES Project # -2025-177

SEPTEMBER 2025 & MAY 2026

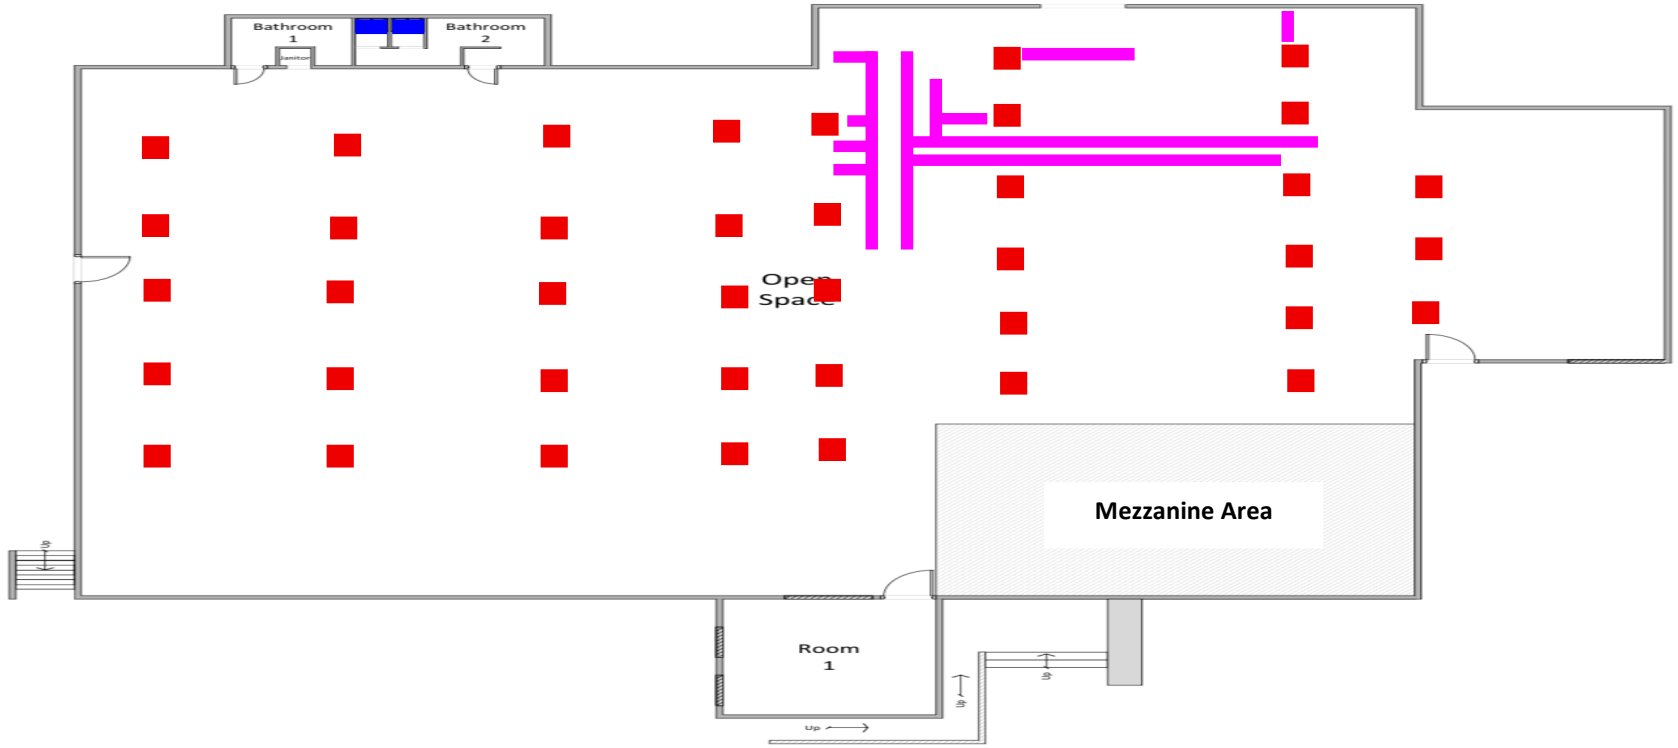
LBP POSITIVE RESULTS LOCATIONS- BUILDING T-0336-0-56-00

= CONCRETE COLUMNS WITH LBP

Global Environmental Services LLC recommends the owner or representative of owner to hire a Company Certified in the Department of Natural and Environmental Resources (DNER) of Puerto Rico to mitigate and dispose positive areas with Lead Based Paint if is going to touch or demolish the project areas.

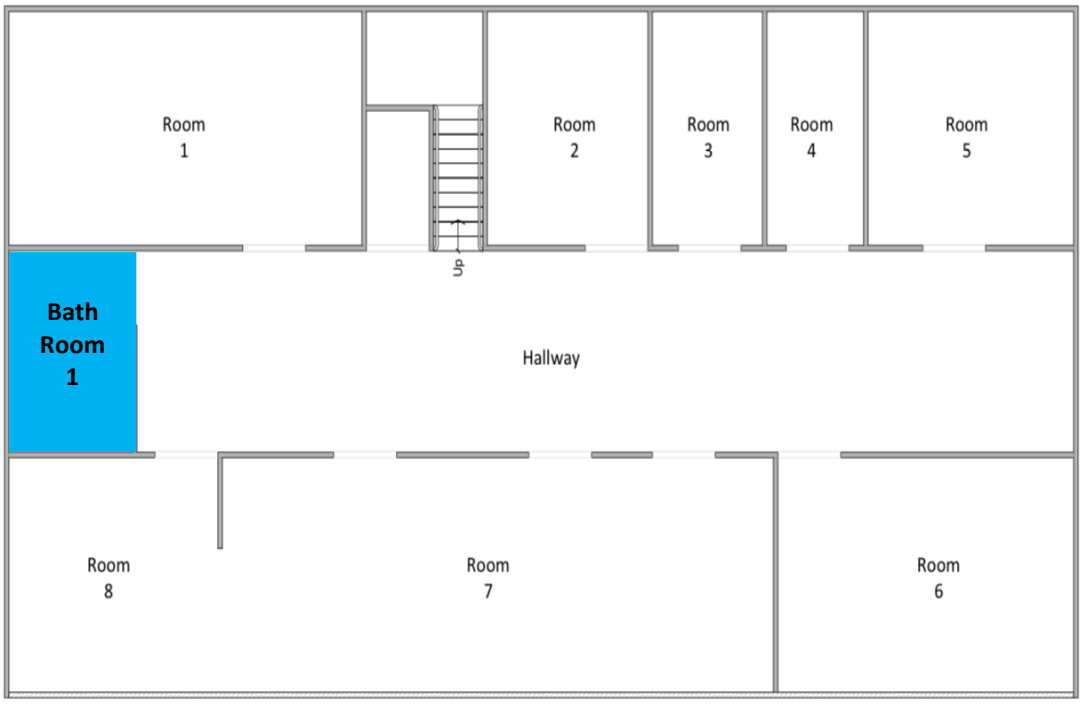
LBP POSITIVE RESULTS LOCATIONS- BUILDING T-0336-0-56-00- MEZZANINE- FIRST FLOOR

= CERAMIC FLOOR TILES WITH LBP
